FRIENDS MEETING OF WASHINGTON

CONCEPT DESIGN

Meeting House Building Analysis

by
QUINN EVANS | ARCHITECTS

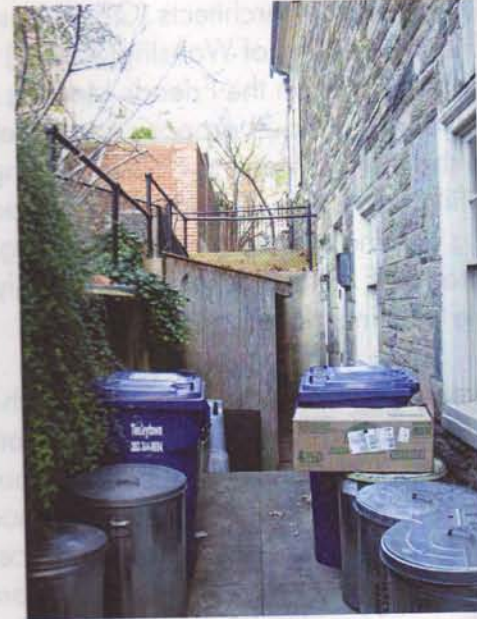
Areaway at Kitchen

Water Infiltration through Exterior Kitchen Door

In the Fall of 2008, new site interceptor drains were added to the landscape in hopes of mitigating the water infiltration issues. These drains 'outfall' into an open drain located in the areaway adjacent to the Lower Level Kitchen. Because of this added stormwater, the capacity of the existing areaway drainer is being overcharge and water is backing up into the areaway and, ultimately, into the Kitchen.

Solution: The drain line for the new site interceptor drains should be redirected along the side of the building to the combined sewer line under Decatur Place.

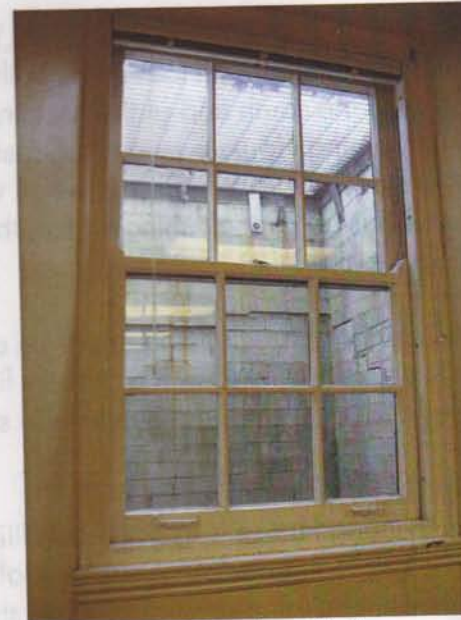
Lower Level Window Wells

Water Infiltration Through Walls at Window Wells

There are six window wells along the perimeter of the Meeting House. Each window well has an areaway drain. Over time, these drains have clogged and rain water has overflowed directly into the adjacent interior space.

Solution: The window well drains should be cleaned out to a distance of at least 100 feet. A steel grille should be provided at each window well to keep trash and leaves out.

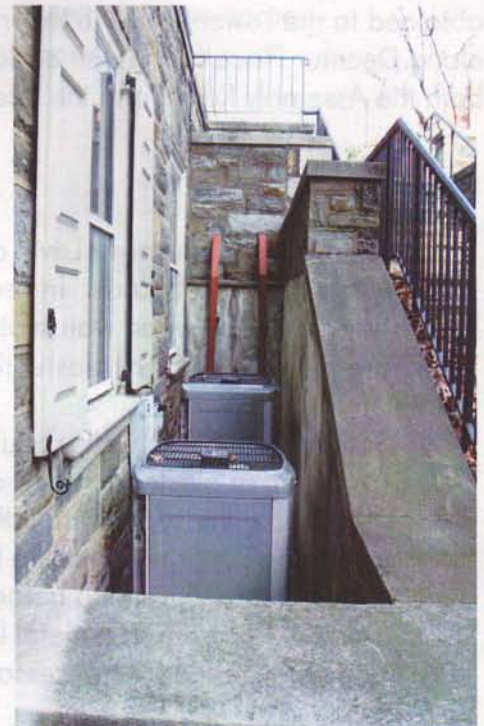
Water Infiltration into the Decatur Room

Water infiltrates into the Decatur Room through the wall and around the window. The upper areaway and terrace drain into the lower areaway adjacent to the Decatur Room through two scuppers. When this areaway fills, it causes water to leak into the adjacent space.

Areaways outside the Decatur Room with two red scuppers

Solution: The scuppers are blocked with leaves and should be cleaned out. The drains and the drain lines should be cleaned out.

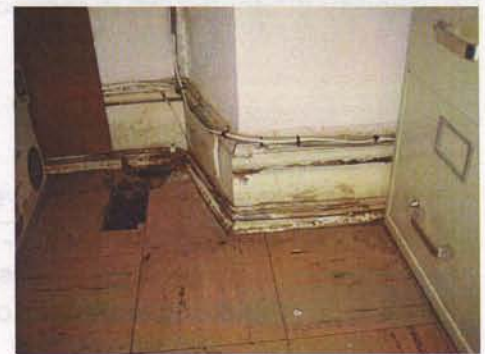
Baseboard at office (108)

Wood baseboard runs throughout the Lower Level. The baseboards vary from good to poor condition depending on its location and exposure to moisture.

Solution: All of the wood baseboard shall be stripped and refinished. Where damaged beyond repair, the baseboard should be replaced in kind (i.e. storage room, west wall of office 108).

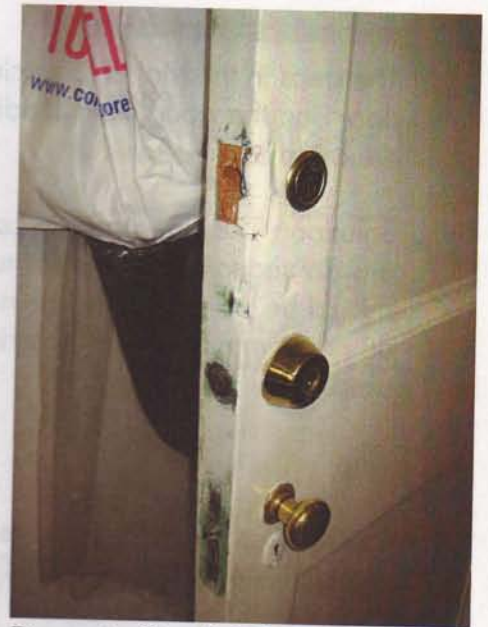
Door at office (112)

Many of the doors within the building are metal wrapped wood core doors and have sustained damage.

Solution: Because it is unlikely this condition can be repair, the damaged doors shall be replaced with a wood paneled door to match. All wood doors shall be stripped and repainted.

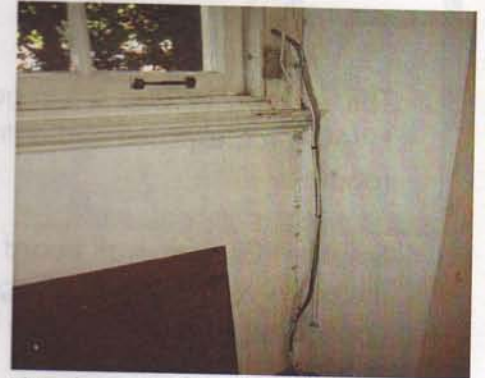
Window at office (108)

The windows on the Lower Level are wood frame and single glazed. Most of the windows are in good shape. A window in the library (106) has a broken muntin. The window frames in office (108) are in poor condition.

Solution: The windows in good condition shall be stripped and refinished. The damaged windows shall be repair as required.

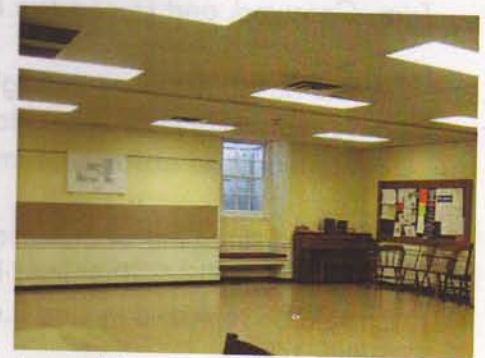
Assembly room ceiling

The concrete ceilings are in good repair but they leave the HVAC ducts exposed and detract from the aesthetics of each room.

Solution: Gypsum wall board (GWB) ceilings should replace the areas with ACT tile ceiling. The HVAC ducts should be configured to best be hidden by new drop ceilings or new bulkheads.

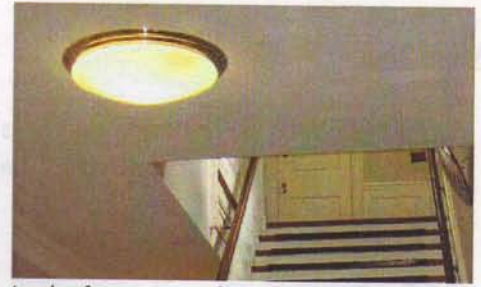
Light fixtures in first floor hall

recently been replaced. Ceiling mounted pendant fixtures have been installed in the Entry Hall and are in good condition.

Solution: Within the 'public' areas of the Meeting House, the fluorescent light fixtures shall be replaced with compact fluorescent downlights and ceiling mounted fixtures.

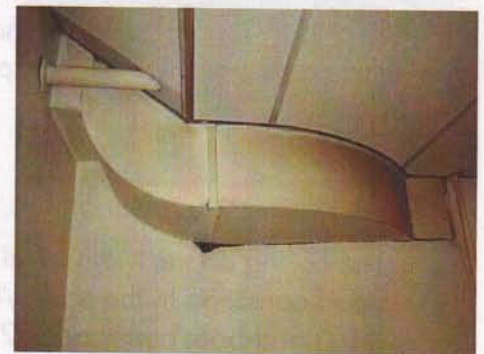
The furnace and air handling units for the building are new. The layout of the duct work is ineffective. The rooms in which the ducts are exposed are the kitchen (104), storage room (102), hallway (105), the office (108) and both bathrooms (110/111).

Duct in kitchen coming from furnace room

Solution: At a later phase of the project, a mechanical engineer will be commissioned to evaluate the effectiveness of the existing mechanical system. The ductwork shall be reworked where required or covered with a drop ceiling or soffit.

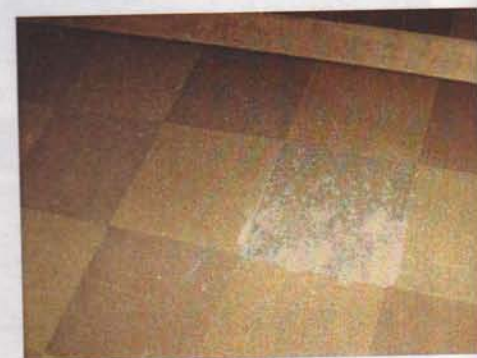
The Main Level has many different types of flooring. The parlor/library (202/203) and part of the hallway (207) have wood floors. The meeting room (201) has cork tile flooring. The tile floor is significantly worn. The classroom (204) has VCT and worn.

Cork tile flooring at Meeting Room (201)

Solution: The wood floors shall be sanded and refinished. The cork floor tile shall be replaced. The VCT shall be replaced.

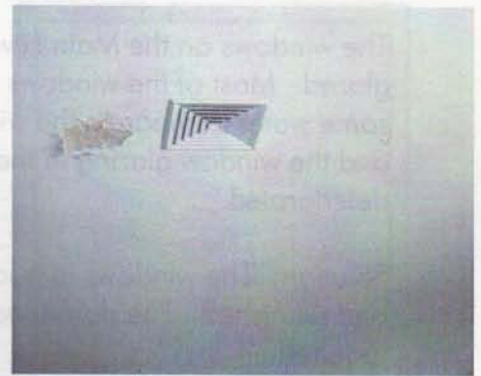
The ceiling on the Main Level is plaster. The plaster is in good condition in the parlor/library (202/203), the hallway (207) and both bathrooms (205/206). The plaster ceiling in the meeting room (201) has been damaged by water

near the southeast HVAC vent (see picture to the right). This damage is caused by water infiltration at the roof ridge vent. Acoustic tiles are attached to the plaster ceiling in the classroom (204) with an adhesive.

Damaged plaster ceiling in Meeting Room (201) from a roof leak

Solution: The ridge vent should be replaced with a custom fabricated copper assembly that will provide greater protection against wind-driven rain.

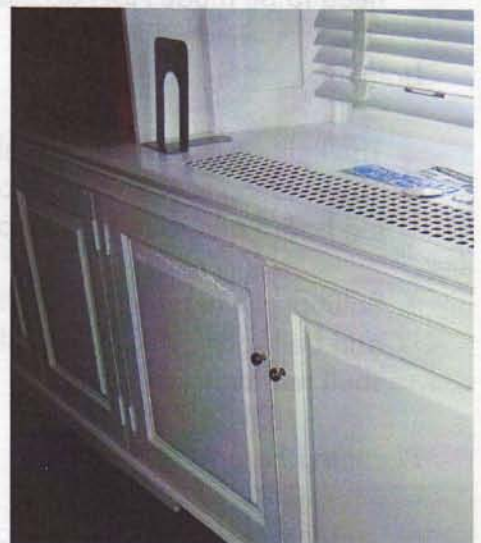
The parlor (202/203), hallway (207) and meeting room (201) all have wainscot trim. The cabinets, bookcases and mantle surround in the parlor (202/203) are in excellent condition. It is suggested that the unused air handlers in the cabinets underneath the windows be removed.

Air handling unit inside cabinetry at the Library/Parlor

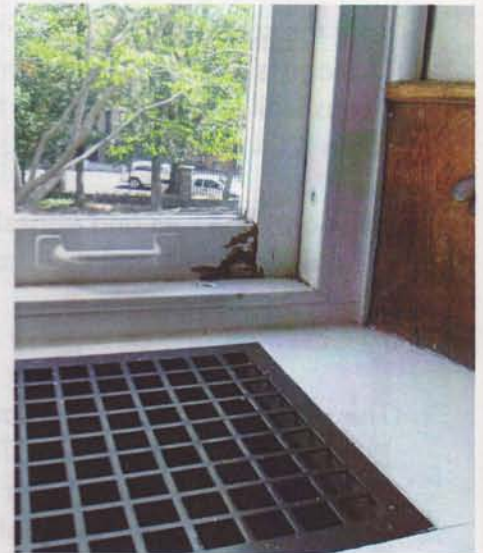
The windows on the Main Level are wood frame and single glazed. Most of the windows are in good shape. There is some water damage to the windows in the Meeting Room and the window glazing in the Meeting Room (201) is badly deteriorated.

Water damage at Meeting Room (201) windows

Solution: The windows in good condition shall be stripped and refinished. The damaged windows shall be repair as required.

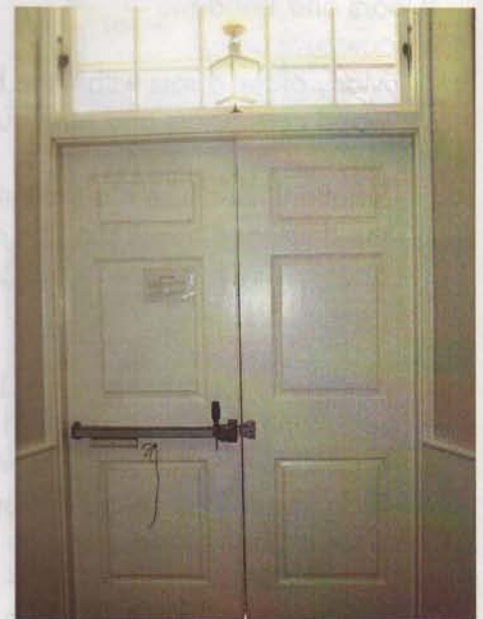
Second floor vestibule doors in hall

The metal trim above the parlor door (room 202) is damaged and should be repaired and refinished. The panic hardware on the double exterior door in the hallway (207) is damaged and does not work and should be replaced (see bottom right image).
