# FRIEND'S MEETING OF WASHINGTON

## EVALUATION OF EXISTING CONDITIONS AND RECOMMENDATIONS FOR FUTURE IMPROVEMENTS AND RENOVATIONS

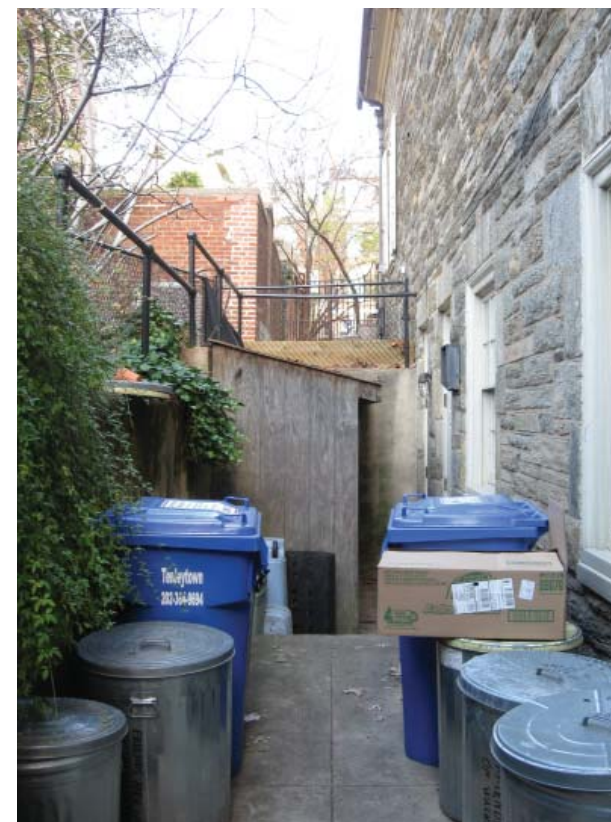
Last Fall, new site interceptor drains were added to the landscape. All the inflow water that is caught by these drains is piped into the open drain of the areaway opposite the kitchen. It is possible that if this new drain line is successful at intercepting rain water in the upper site area, it could overtake the capacity of the existing areaway drain. It should be considered to reroute this new drainage underground, down the side of the building and then to enter the combined sewer in Decatur Street.

Areaway at kitchen where the new interceptor drains flow water to

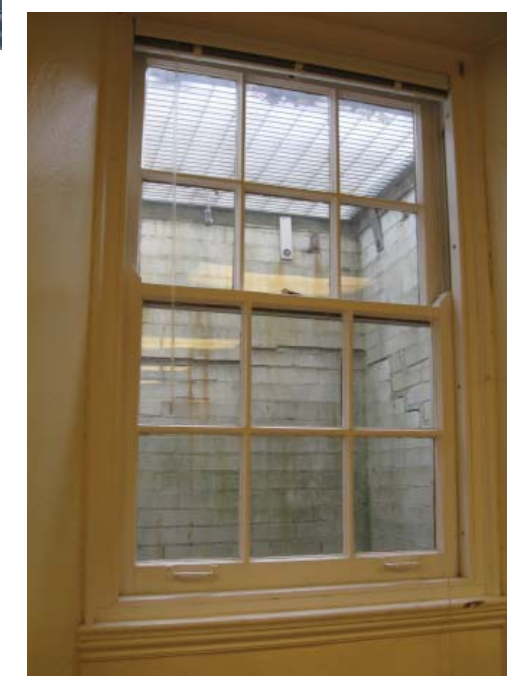
There are 6 areaway drains in light wells around the perimeter of the first floor. It is clear that over time, these drains have clogged and rain water have overflowed directly into the space opposite. These drains should be cleaned out with Roto-Rooter to a distance of at least 100 feet. Some of the areaways have steel grilles to keep animals and large trash out.

Areaways around basement windows where drains are becoming clogged

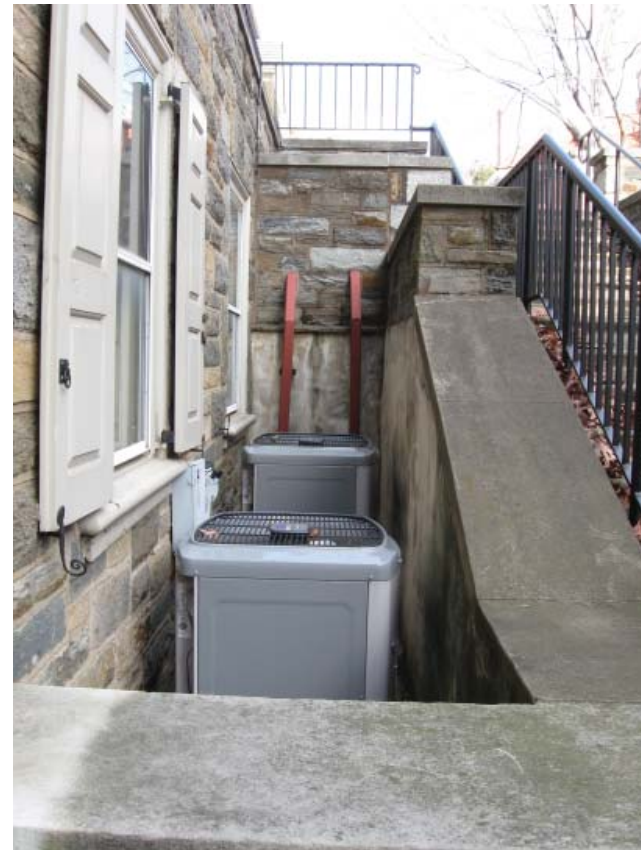
Areaways outside the Decatur Room with two red scuppers

When the addition was built in 1950 additional water infiltration problems were made. The areaway outside the Decatur Room (114) traps water which infiltrates through the wall and around the window in the room. The upper areaway drains into the lower areaway adjacent to the Decatur Room (114) through two scuppers. These scuppers are blocked with leaves and should be cleaned out. When this areaway fills, it causes water to leak into the adjacent space. The flashing appears in good condition.

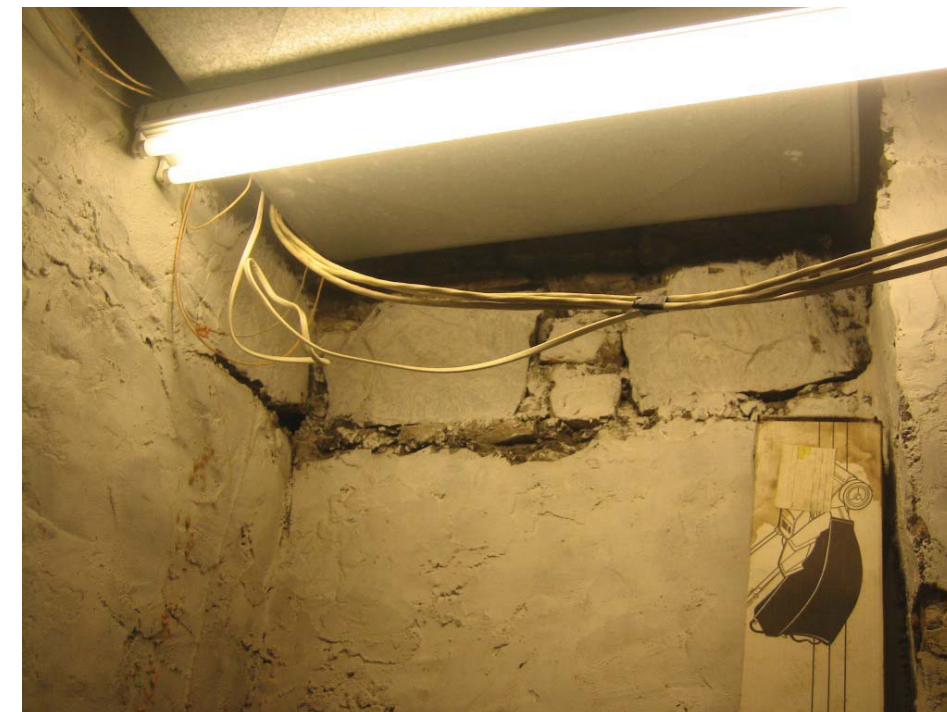
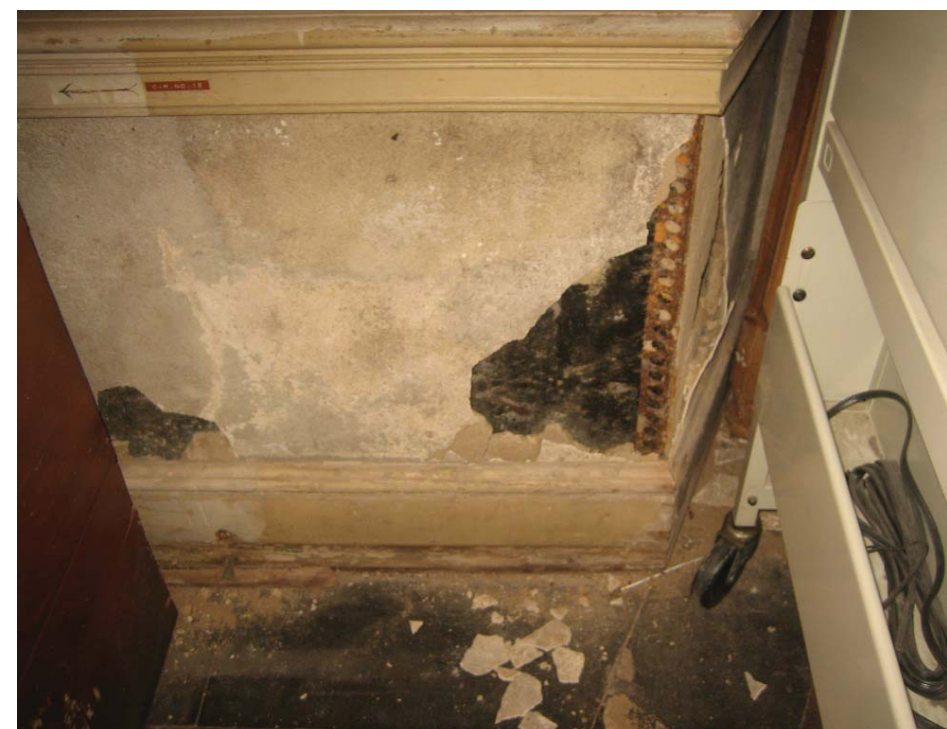
East Wall - There are signs of damage and possible water infiltration in this wall (see picture to the right) - cracks and spalling plaster. The significant areas of plaster spalling seem to be from age and not water damage. The plaster should be tested for soundness and adherence to the lath and repaired as necessary.

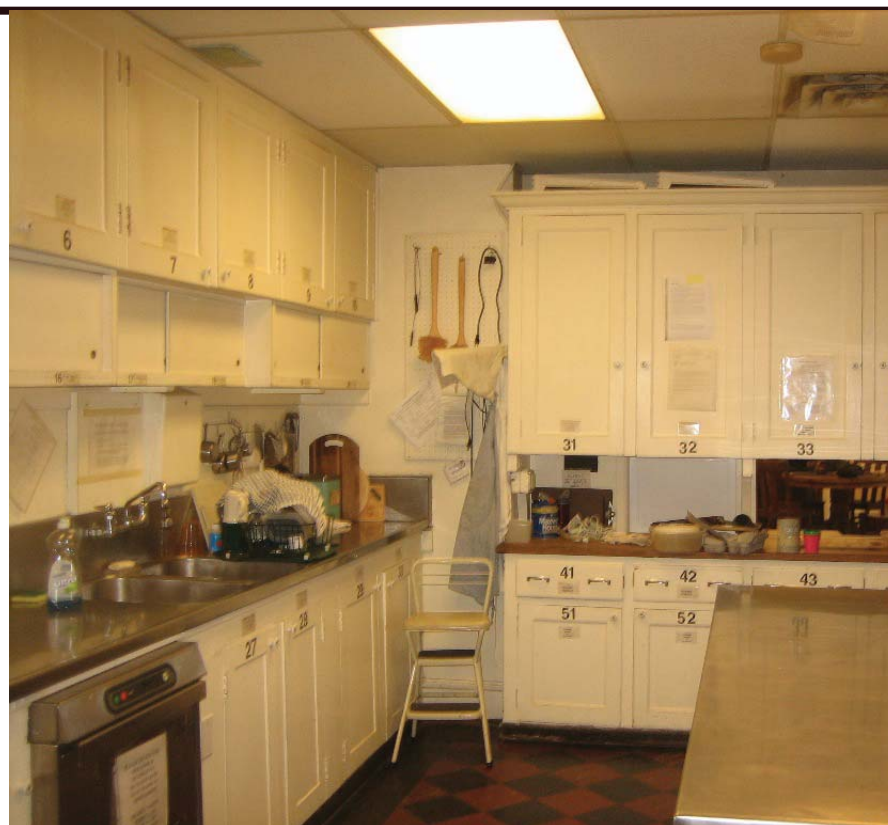
East and South wall of kitchen

East wall - This wall is mainly covered in cabinets which need to be either repaired and refinished or replaced with new cabinets (see top left photo). The pass through at the countertop should be refinished and the hardware replaced. This wall is to be moved to the east during the renovation to diminish the size of the hallway and expand the kitchen. There will be new appliances in the kitchen as well.

South wall - The south wall is also mainly covered in cabinetry and the same treatment should apply here, either repair and refinish existing or replace with new. The pass throughs here need to be stripped and refinished.

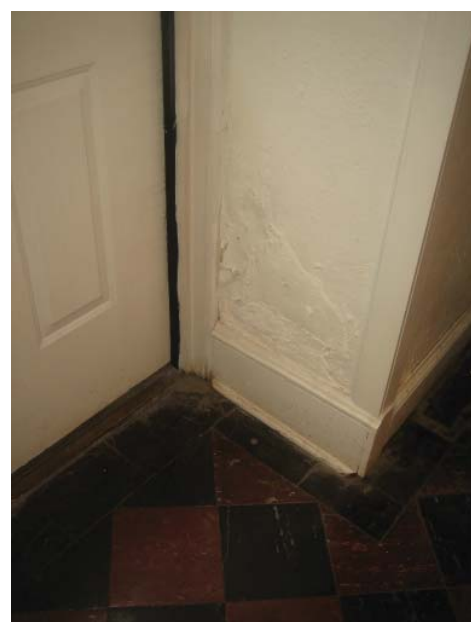
Water damage at west kitchen wall

West wall - This wall has some effluorescence of the plaster near the exterior door which once repaired should be eliminated by the new water-proofing (see bottom left photo). The existing through-wall fan which is no longer functioning should be removed and the wall patched as appropriate.

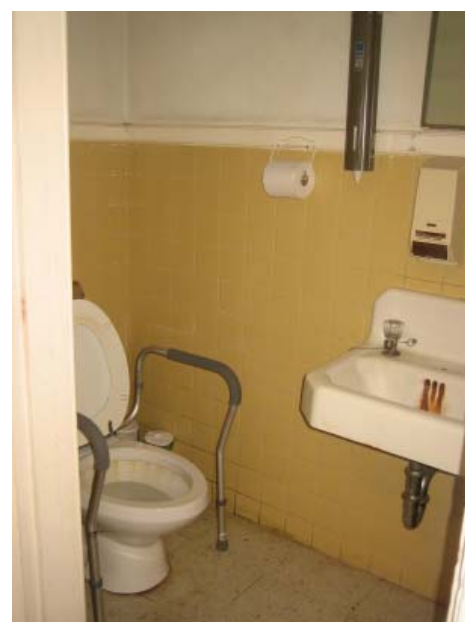
Bathroom 103

All walls are covered to approximately 5 feet with older ceramic yellow tile that should be removed and the plaster beneath repaired (see photo to the bottom left). This room is being converted to storage concurrently with the renovation.

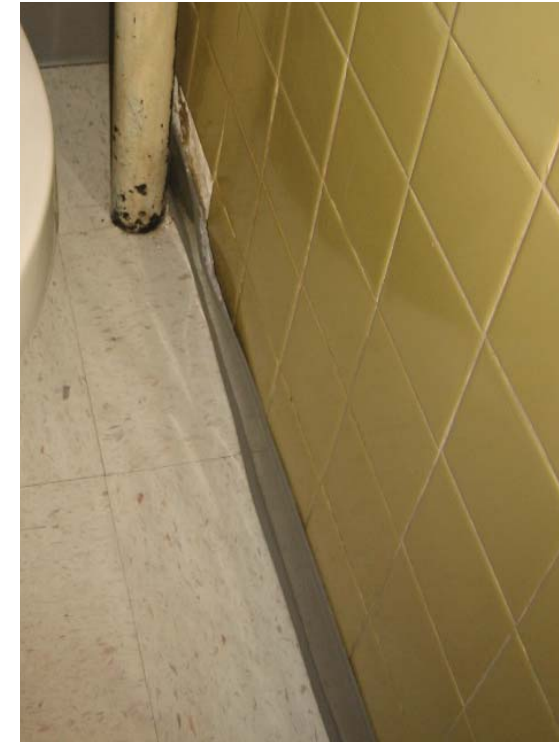
All plaster walls are wainscotted with dated yellow ceramic tile and the south and east walls seem to be in fair condition. The west wall has some plaster peeling and spalling from apparent water damage and the north wall has some missing tile possibly from water damage. There is also a bulge in the tile about halfway up the tile wainscot on the north wall. The tile should be removed, the plaster underneath assessed and repaired if needed and new tile installed.

Tile in bathroom (110)

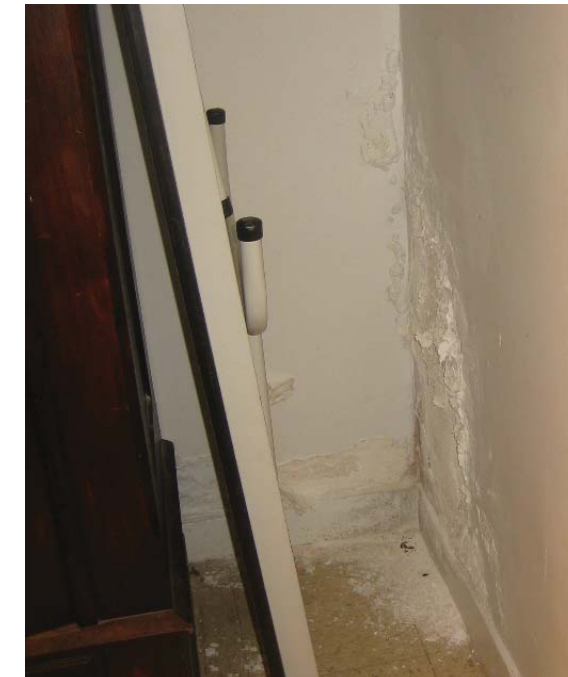
There is significant water damage (effluorescence) within this room on the east wall especially around the windows. After a waterproofing endeavour is undertaken the plaster needs to be checked for soundness and attachment to the lath and repaired as needed.

Water damage in Decatur Room

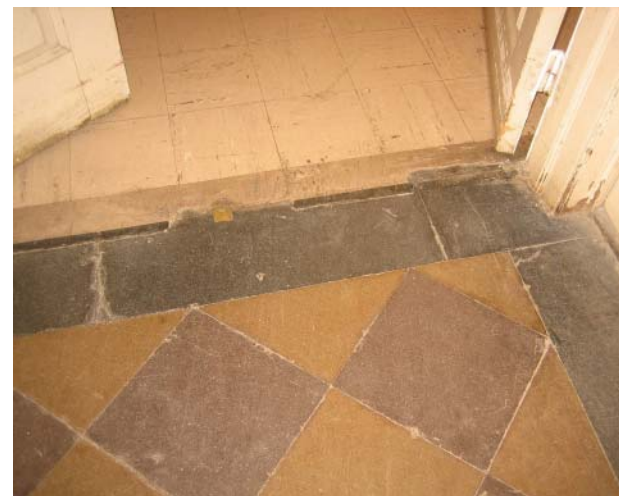
Original tile at storage room (102)

Throughout the first floor old VCT tile is prevalent, cracked and discolored. QEA recommends that this tile be taken up and replaced with new tile. The kitchen 104 and storage room 102 have what seems to be original tile and it is in very rough pitted shape. It should be determined whether it is desirable to keep the tile due to historic integrity or replaced for a more aesthetic appeal.

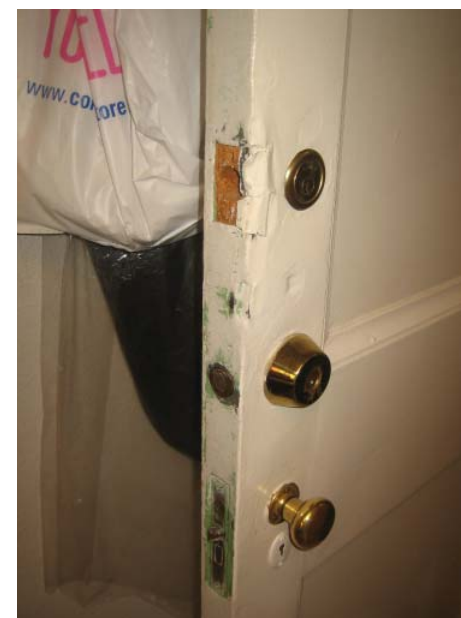
Many of the doors within the building are metal wrapped wood core doors and have sustained a lot of damage at the jamb (see picture to the right). This condition should be repaired as best as possible and the doors should be stripped and refinished. All wood doors should be stripped and repainted. Every room has a separate key for the lock. All hardware should be made uniform with a master key system for better security and aesthetic cohesiveness.

Door at office (112)

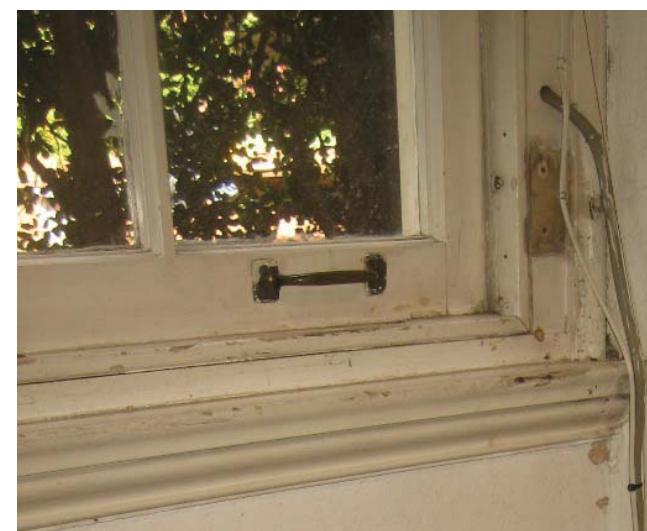
All the windows at the first floor are wood frame and single glazed. Most windows are in good shape and just need to be stripped and refinished. There is a window in the library (106) that has a broken mullion which needs repaired. The frames in office (108) are in poor condition and need to be assessed for their structural stability (see picture at bottom right).

Window at office (108)

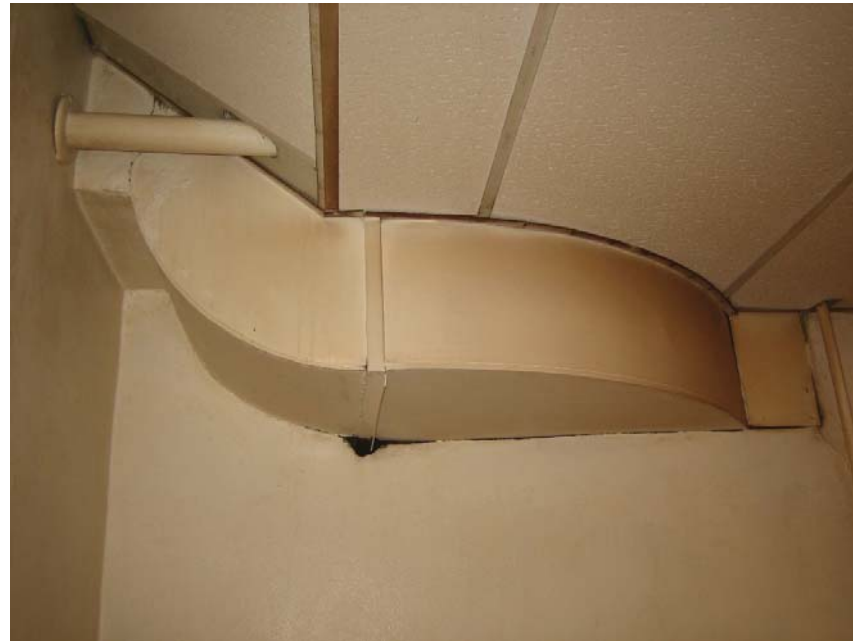
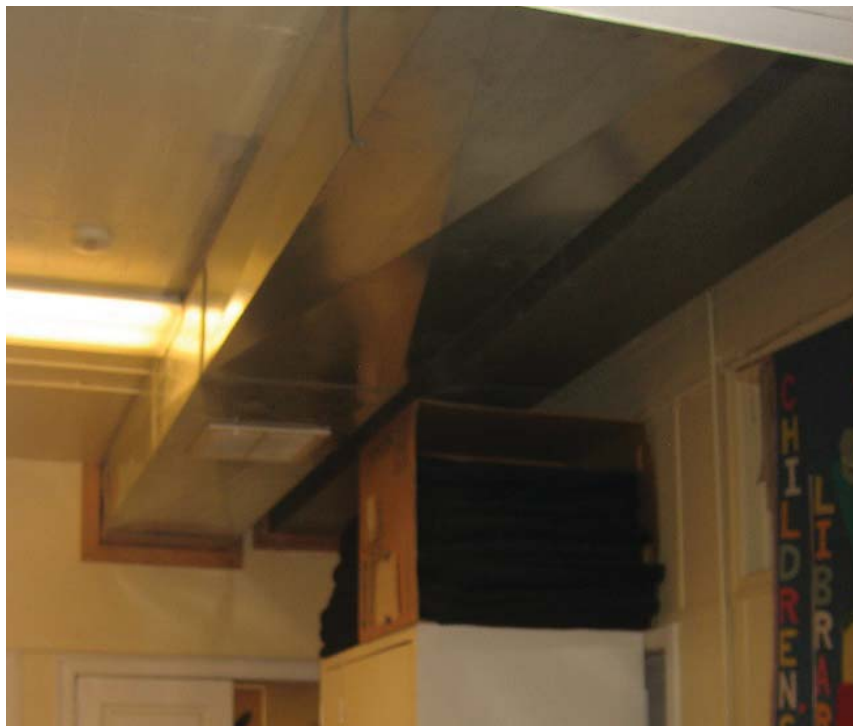
Ducts in kitchen coming from furnace room

Ducts in hallway (105)

The furnace and air handling units for the building are recently new and we do not recommend replacement. The duct work seems to be a bit haphazard and should be either covered with a drop ceiling or made more aesthetically aligned with the rooms and painted to match the ceiling or walls. The rooms in which the ducts are exposed are the kitchen (104), storage room (102), hallway (105), the office (108) and both bathrooms (110/111). (Images to the left: Top - ductwork at kitchen and bottom - ducts at library hallway).

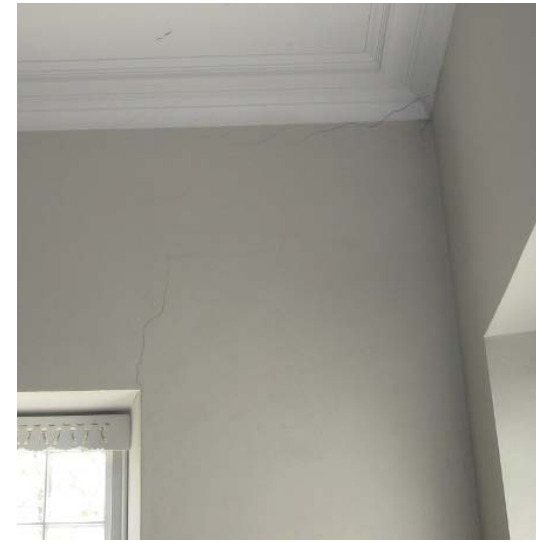
There is minor damage to the walls on the southeast corner due to what seems like settlement cracks. The cracks run straight through the cornice which indicates that it is a plaster cornice. This should be patched and repaired once the cause for the cracking is determined (see top right image).

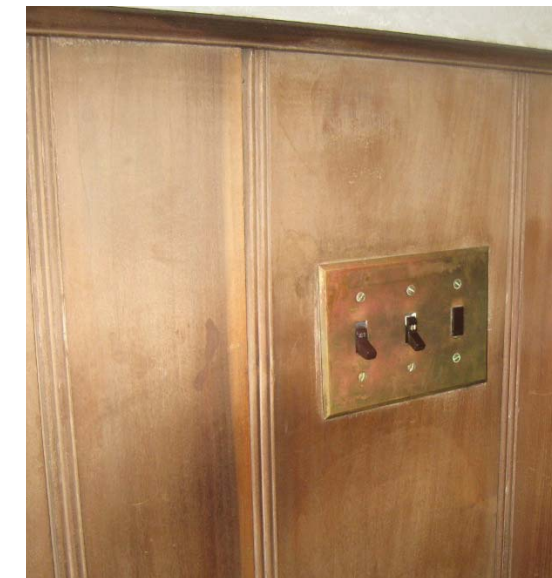
The wood beadboard panelling (image to the right) in the meeting room needs to be refinished and a clear coat added to protect the wood from wicking moisture.

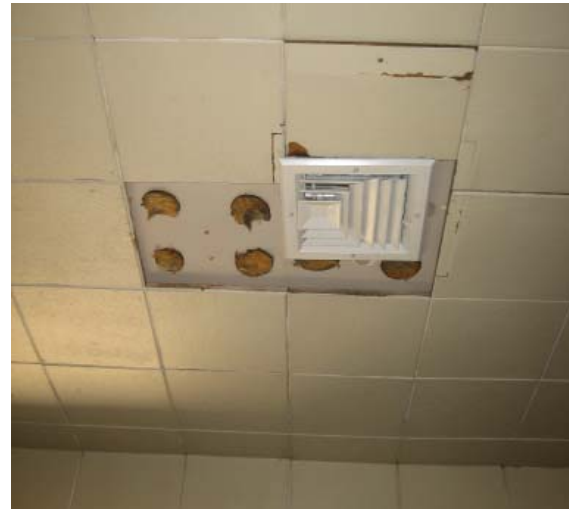
Acoustic tiles at classroom (204)

The walls in the classroom are covered with an acoustic tile that is attached to the plaster below with an adhesive. Aesthetically the tile is not desired and it should be removed, the mastic below cleaned off and the plaster repaired. If noise levels are a problem in this room a better, more aesthetically pleasing solution shall be developed.

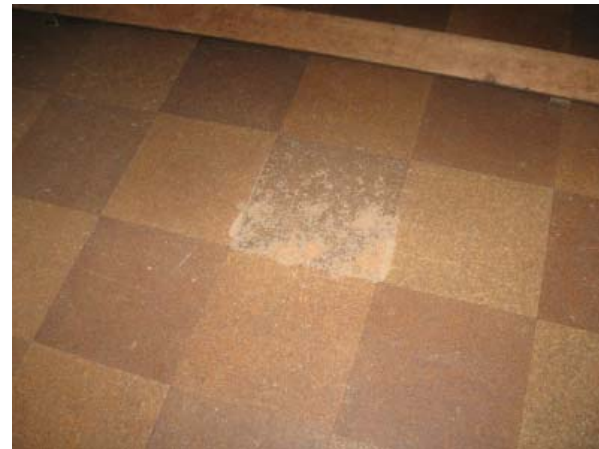
Cork tile flooring at Meeting Room

The meeting room (201) has cork tile flooring and it is very worn and dated (see image on the middle left). QEA recommends that new cork tile or wood flooring is installed.

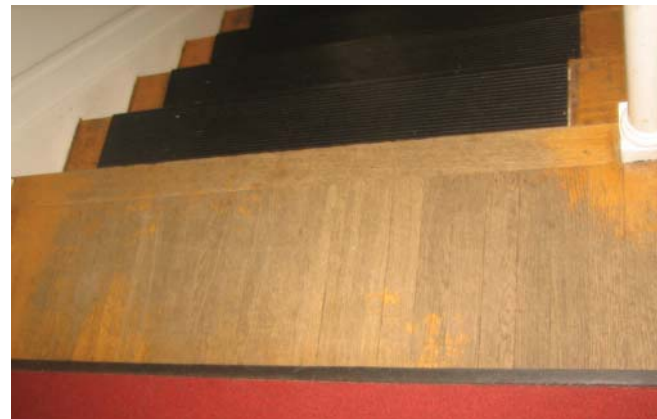
Wood flooring at second floor hall (207)

The second floor has many different types of flooring all possibly original except for the newly renovated bathrooms (205 and 206). The parlor/library (202/203) and part of the hallway (207) have wood floors. The wood may or may not be original, the wood slats are fairly narrow for the age of the building which leads one to believe that they are not. They do need to be sanded and refinished due to wear (see bottom left image).

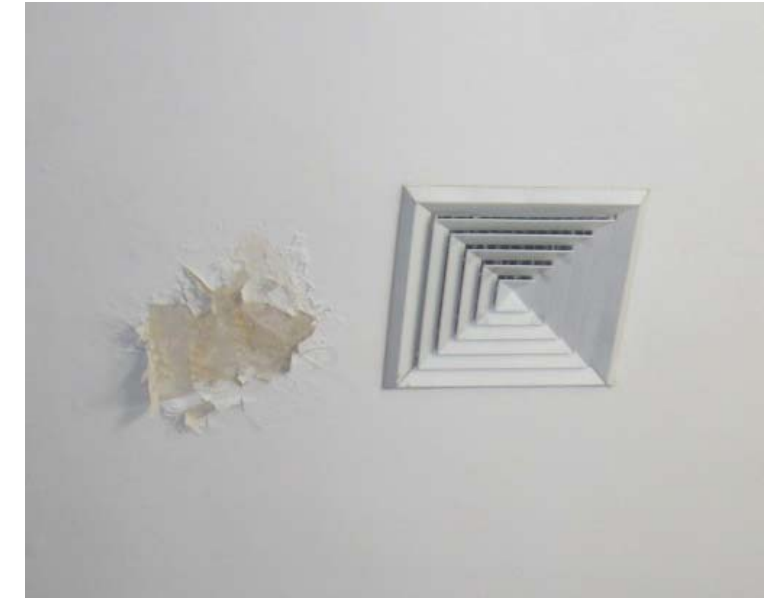
The ceiling on the second floor is plaster. The plaster is in good condition in the parlor/library (202/203), the hallway (207) and both bathrooms (205/206). The plaster ceiling in the meeting room (201) has been water damaged near the southeast HVAC vent (see picture to the right). This damage is caused by a leak in the asphalt shingle roof.

Damaged plaster ceiling in Meeting Room (201) from a roof leak

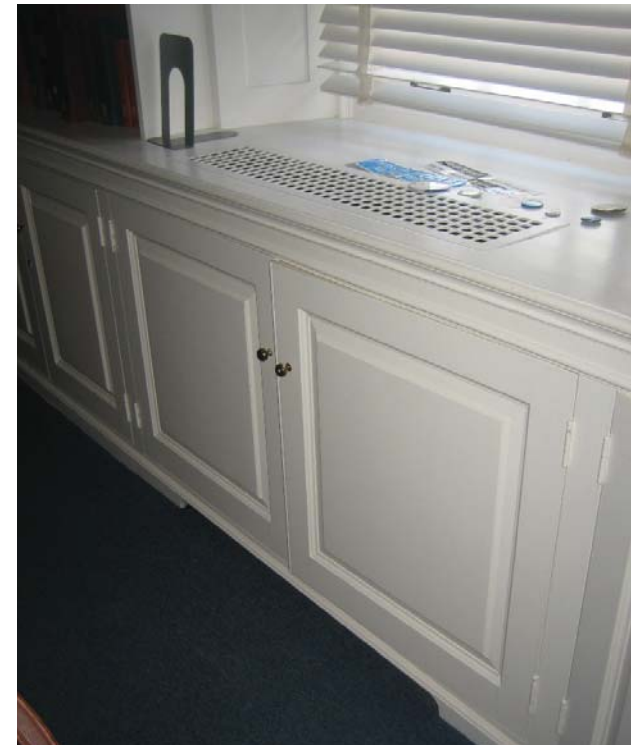
The cabinets, bookcases and mantle surround in the parlor (202/203) are in excellent condition. It is suggested that the unused air handlers in the cabinets underneath the windows be removed (see image at bottom right).

Air handling unit inside cabinetry at the Library/Parlor

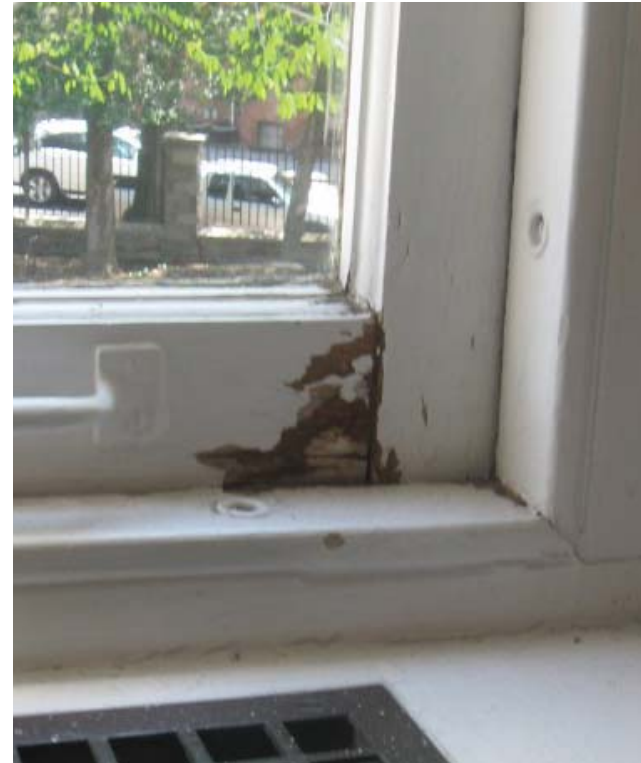
Water damage at Meeting Room (201) windows

All the windows at the second floor are wood frame single glaze double hung windows and are generally in good condition. There is some water damage to the windows in the Meeting Room and it should be evaluated and repaired as required (see picture to the left). The window putty at the windows in the meeting room (201) is badly deteriorated and should be replaced as well.

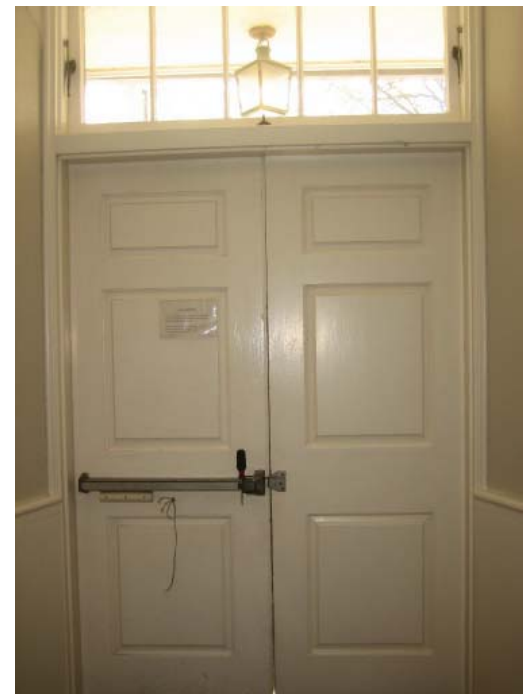
Second floor vestibule doors in hall

The metal trim above the parlor door (room 202) is damaged and should be repaired and refinished. The panic hardware on the double exterior door in the hallway (207) is damaged and does not work and should be replaced (see bottom left image).

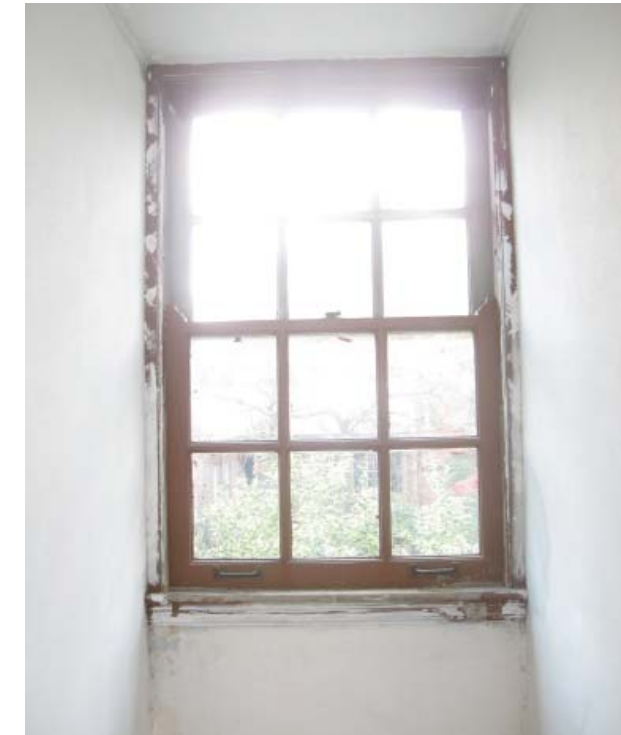
Window and door trim should be stripped and repainted. The windows in classroom (302) seemed like they were in process to be repainted but were never finished (see image to the left).

Dormer window at third floor in process of refinishing

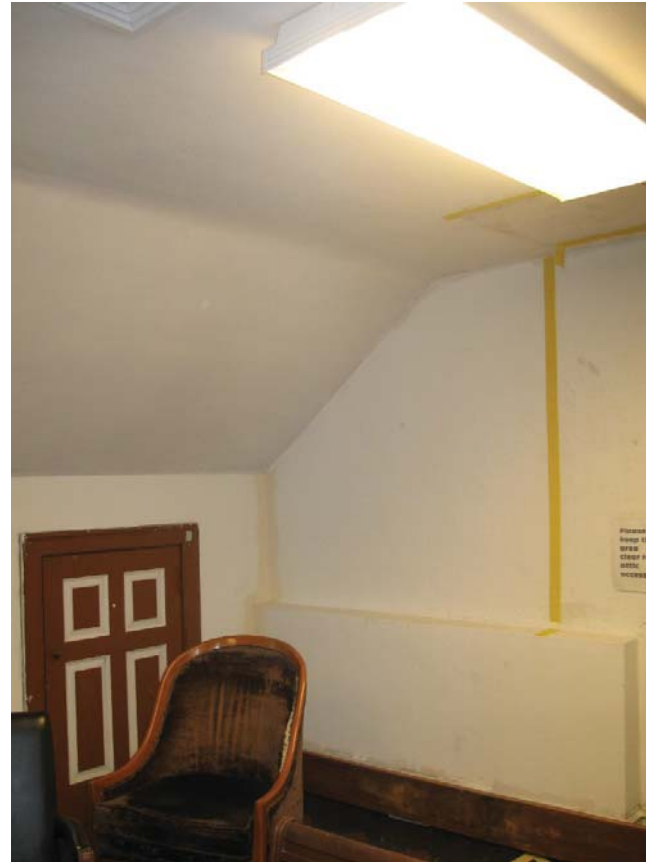
The lights in the classrooms are fluorescent tube ceiling mounted fixtures (see image to the left) and are not aesthetically pleasing. QEA recommends replacing them with a ceiling mounted fixture that is less industrial in nature.
