FRIENDS MEETING OF WASHINGTON

CONCEPT DESIGN

Meeting House Building Analysis

by
QUINN EVANS | ARCHITECTS

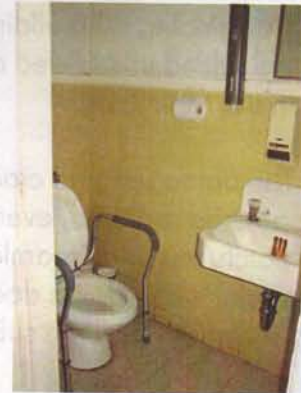
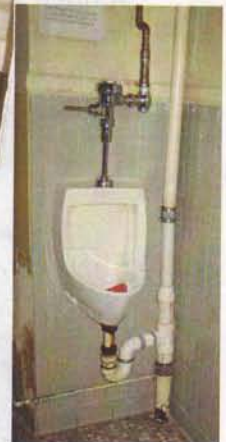
The existing toilet fixtures and lavatories on the Lower Level (3 toilets and 1 urinal) are outdated and inefficient.

Solution: The existing fixtures shall be replaced with low flow fixtures.

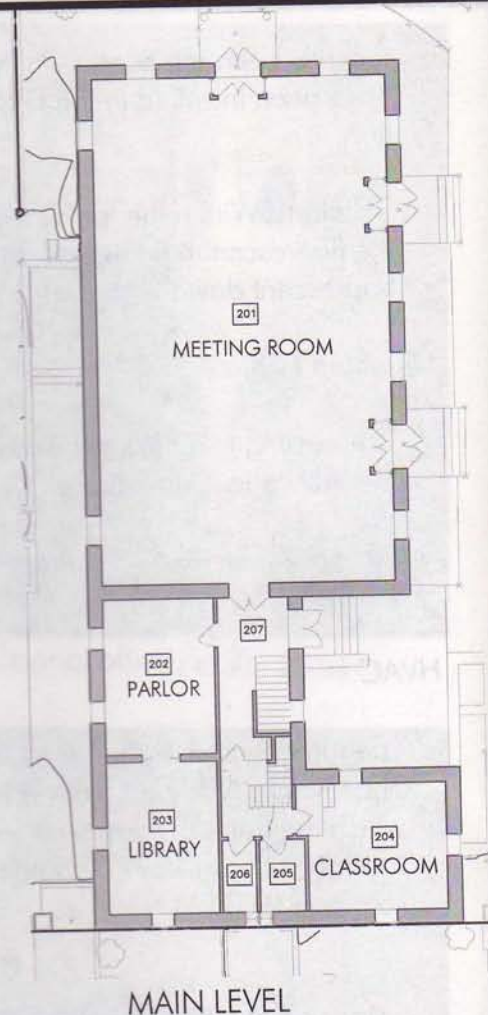
Cork tile flooring at Meeting Room (201)
