# FRIEND'S MEETING OF WASHINGTON

## EVALUATION OF EXISTING CONDITIONS AND RECOMMENDATIONS FOR FUTURE IMPROVEMENTS AND RENOVATIONS

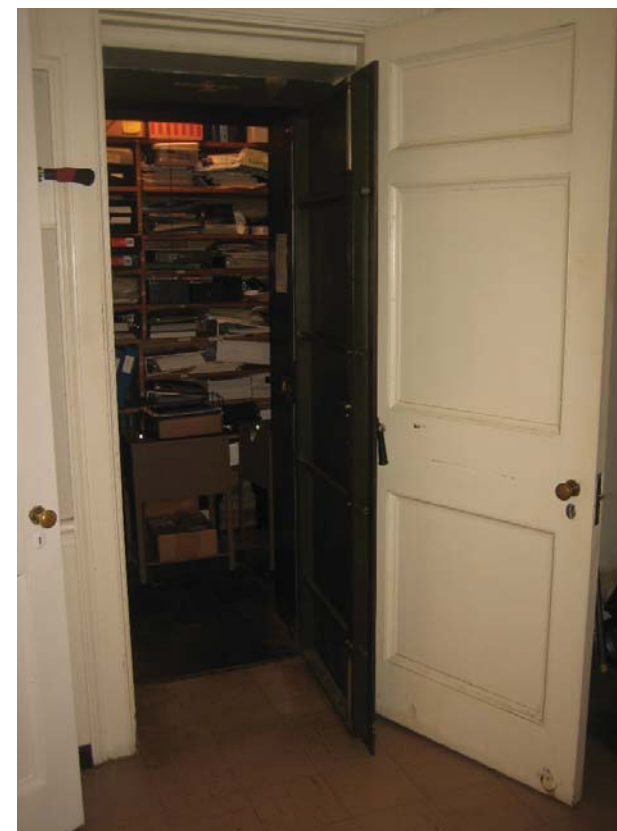
Dual doors looking into the vault

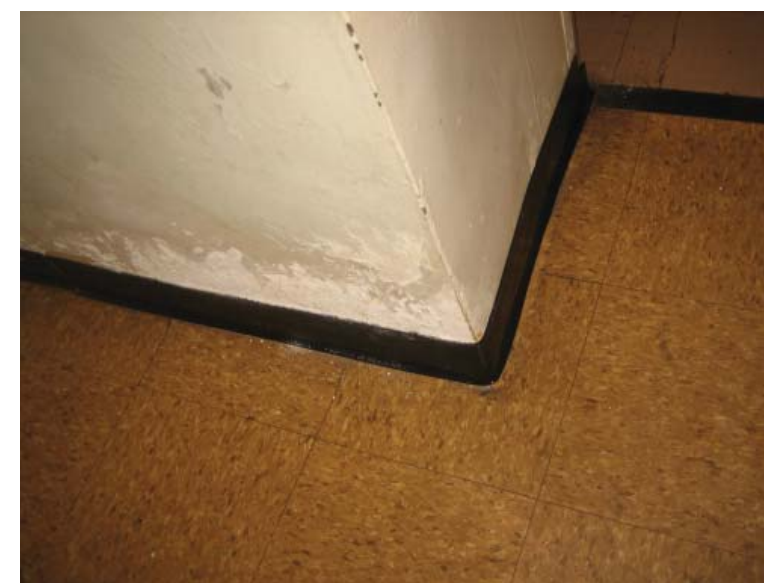
First floor hallway across from bathroom entrances

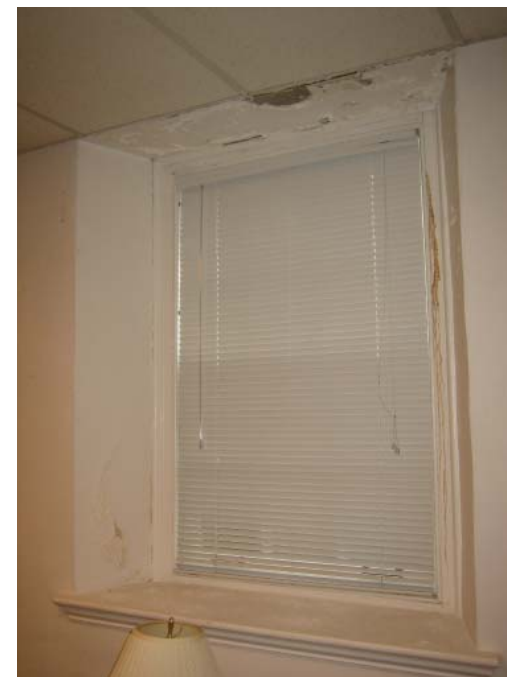
Window in Decatur Room (114)

There is significant water damage (effluorescence) within this room on the east wall especially around the windows. After a waterproofing endeavour is undertaken the plaster needs to be checked for soundness and attachment to the lath and repaired as needed.

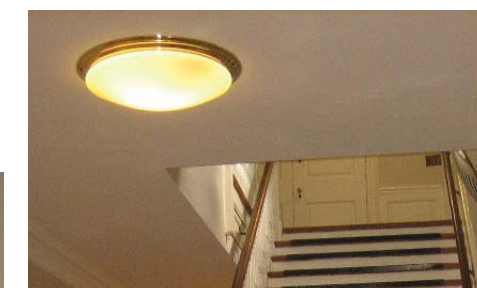
Light fixtures in first floor hall

The lighting at the first floor is generally fluorescent tube lights within the ACT drop ceiling or fluorescent box ceiling mounted fixtures in the offices, storage room and furnace room. New plexi-glass lenses have been installed at the ACT drop ceilings in the past month. Newer ceiling mounted dome fixtures are in place at the hallway and are in good condition. With the upgrades and aesthetic improvements to the building the fluorescent tube light fixtures shall be replaced with more attractive downlights and ceiling mounted fixtures that are energy efficient.
